Sautter Crane Rental

Man basket - *Sautter Yard*

Personnel Lifting Platform: *HMB9*

Man basket
Sautter Crane Rental
 2900 Black Lake Place
 Philadelphia, PA 19154

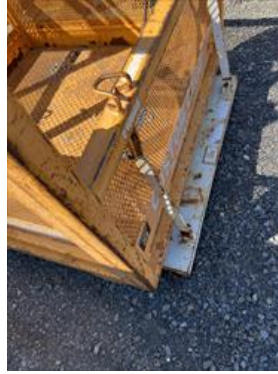
P17.3

● 17. Platform has safe means of proof test for pre personnel lifting. (SAT) Satisfactory P17
