Sautter Crane Rental

Inspection

Lattice Boom Crane

Manufacturer:	Liebherr
Model:	LR 1300.1SX
Capacity:	330 Tons
Length/Lift:	95' Main Boom & 125' Luffing Jib
Hook Type:	Load Block & Hook
Hook Type 2:	Overhaul Ball & Hook

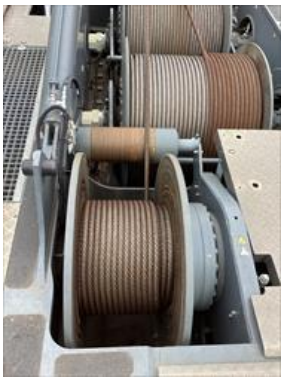
P110.8

110.	Boom Hoist - Wire Rope Reeving	**(SAT) Satisfactory**	P110
111.	Boom Hoist - Meets 2 rope wrap minimum	**(SAT) Satisfactory**	P111
112.	Swing System / Assembly	**(SAT) Satisfactory**

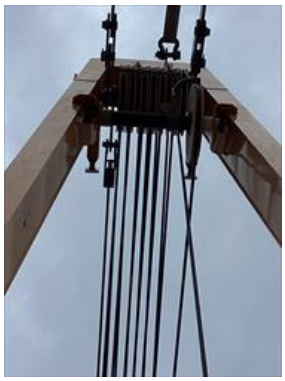
P122.10

119.	Access to Cab and Roof	**(SAT) Satisfactory**	
120.	Air System	**(NA) Not Applicable**	
121.	Counterweight Mounting	**(SAT) Satisfactory**	
122.	Counterweight Warnings SIgns	**(SAT) Satisfactory**	P122
