Hydraulic Boom Crane Annual Inspection Report (1910.180 & 1926.1400)

Telescoping Boom Crane

Location:	Sautter Yard 2900 Black Lake Place Philadelphia, PA 19154
Serial Number:	20216
Unit Number:	S454

Manufacturer:	Grove
Model:	TM-275 LP
Capacity:	30 Tons
Length/Lift:	101'
Type of Crane:	Truck Crane
Number of Hoists:	Main and Auxiliary (Not in Use)
Boom Configuration:	Main Boom w/o Attached Jib
Load Test:	No

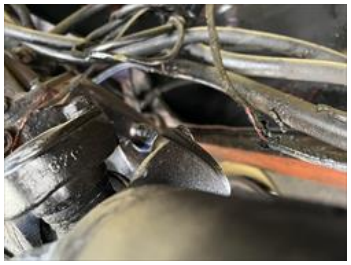
P30.2

●	26.	Per Configuration	**(SAT) Satisfactory**	
●	27.	Durable/Legible/Secured	**(SAT) Satisfactory**	
Carrier				
●	28.	Steering	**(SAT) Satisfactory**	
●	29.	Parking Brake	**(SAT) Satisfactory**	
●	30.	Exterior Lights (Headlights, Turn Signals, Brake Lights, Reverse Lights)	**(REC) Recommendation**	P30
		Marker light missing on right side of crane		
●	31.	Windshield & Wipers	**(SAT) Satisfactory**	
●	32.	Windows & Mirrors	**(SAT) Satisfactory**	
●	33.	Wheels & Tires	**(SAT) Satisfactory**	
●	34.	Engine	**(SAT) Satisfactory**	
●	35.	Exhaust System	**(SAT) Satisfactory**	
●	36.	Axle Lockout	**(SAT) Satisfactory**	
●	37.	Drive Line	**(SAT) Satisfactory**	
●	38.	Main Frame Members	**(DEF) Deficiency**	P38
		Wires rubbing on forward rear driveshaft yoke. Worn through to bare wires.		
●	39.	Hoses/Fittings//Valves	**(SAT) Satisfactory**	
●	40.	Hydraulic Tank & Fluid Level	**(SAT) Satisfactory**	
●	41.	Slip Resistant Walking Surfaces	**(SAT) Satisfactory**
