Man basket - *Sautter Yard*

Personnel Lifting Platform: *HMB4*

Man basket
Sautter Crane Rental
2900 Black Lake Place
Philadelphia, PA 19154

Description: Man Basket

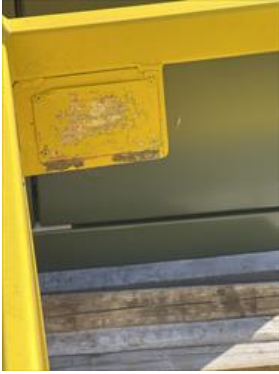
P11.1

● 11. Weight and rated capacity clearly and permanently posted on platform? (Y) Yes P11

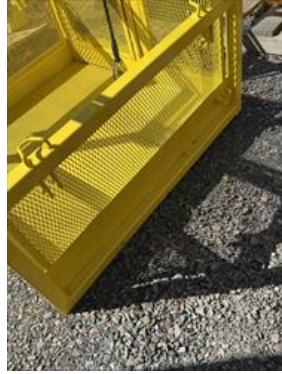
P17.2

● 17. Platform has safe means of proof test for pre personnel lifting. (REC) Recommendation P17
Test weight not with unit at time of inspection. Must be installed before use.
