## **Sautter Crane Rental**

Inspection - <i>Sautter Yard</i>	Boom Truck Crane: 1T9I4792JDW140742 - S185	2	1	1	<b>1.0</b>
----------------------------------	---	---	---	---	------------

### Boom Truck Crane

**Serial #:** 1T9I4792JDW140742

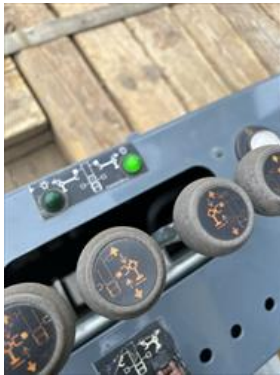
P70.1

70. Outrigger / Stabilizer Position Sensor	(DEF) Deficiency	P70

Right rear outrigger extended position light not working		
Upper Structure

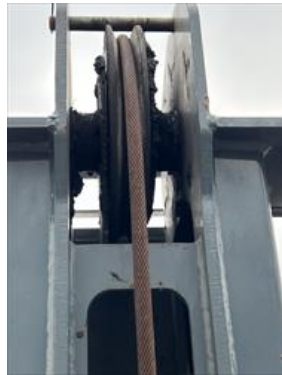
P90.2

90. Sheave(s)	(MON) Monitor	P90

Slight play in top sheave bearing
